Manhole Inspection Summary

Manhole # S07CC2018MH

Location Address: **6010 STEELE RD**

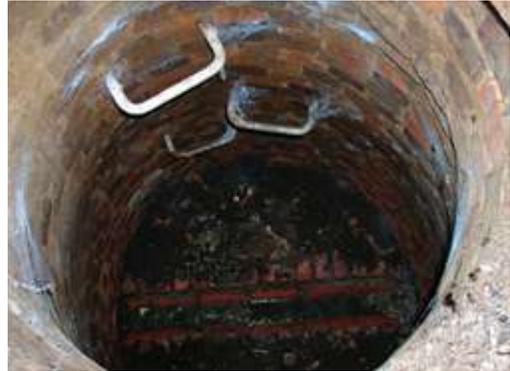
Defect

Bench debris, Adjustment and Barrel infiltration

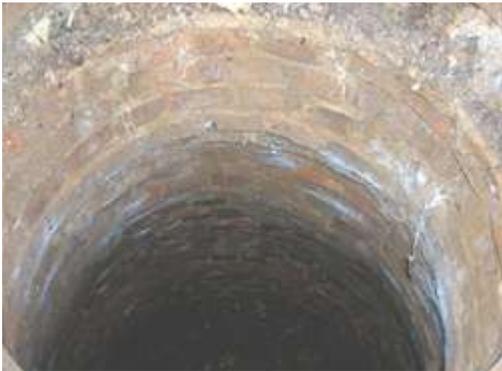
Defect

Condition: Sound **Cracked** Root Intrusion Loose Brick Deteriorated

Infiltration: None **Joint** Cracks **Mortar** Roots Wall

Adjustment Crack and infiltration

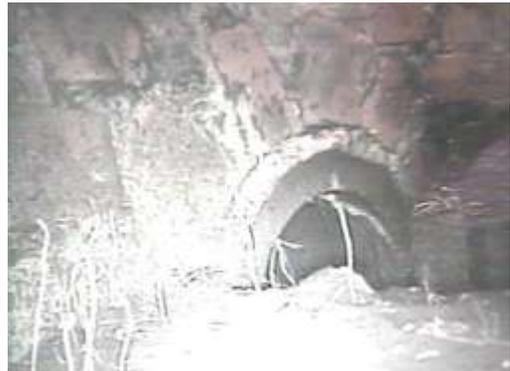
Defect

Condition: Sound Cracked **Root Intrusion** Loose Brick Deteriorated

Infiltration: None Joint Cracks **Mortar** **Roots** Wall

Barrel and bench roots, Barrel Infiltration

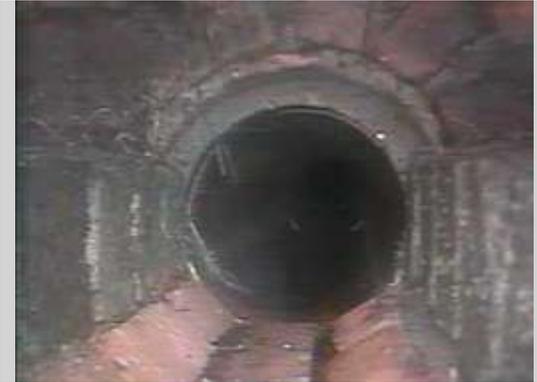
**8 in. Circular Gravity Sewer
Pipe Out @ 12 O'Clock**

Infiltration: **Evidence** Pipe Seal Cond: **Roots**
